# Manhole Inspection Summary

Manhole # S15I1\_014MH

**Inspection** ☐ Is Incomplete Rating: **2) Good**

**Location** Address: **3209 rosalie rd** Cross Street: **w patapsco av**

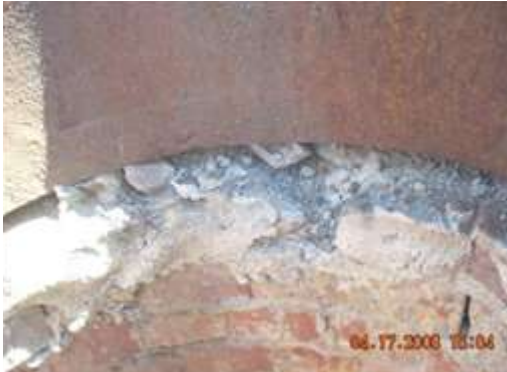
Defect 2

Condition: ☐ Sound ☐ Cracked ☐ Root Intrusion ☐ Loose Brick ☒ **Deteriorated**

deteriorated chimney

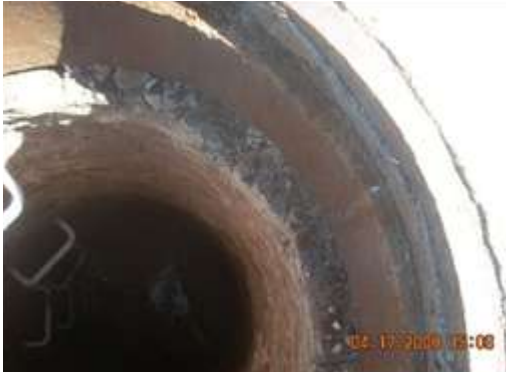
Defect 1

**Frame** Offset: **3** (in.) Condition: ☒ Sound ☐ Cracked ☐ Leaks

frame offset

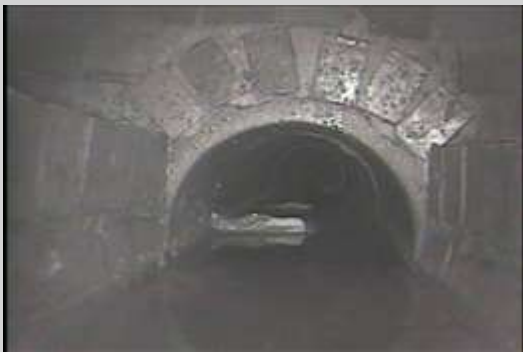
12 O'Clock Outflow

12 in. Circular Gravity Sewer  
Pipe Out @ 12 O'Clock

Pipe Height: **12** (in.) Rod and Bar (Angled)  
Pipe Material: **Clay** ☐ Pipe Lined  
Invert Depth: **17.72** (ft.) Flow Characteristics: **Slow**  
Deposits: ☒ None ☐ Mud ☐ Sludge ☐ Debris ☐ Grease  
Silt Depth: **0** (in.) Deposits Extent:  
Infiltration: **None** Pipe Seal Cond: **Sound**

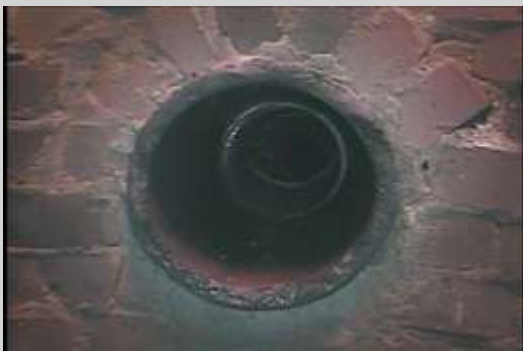
5 O'Clock Inflow

8 in. Circular Gravity Sewer  
pipe In @ 5 O'Clock

drop In @ 5 O'Clock

Pipe Height: **8.4** (in.) Rod and Bar (Angled)  
Pipe Material: **Clay** ☐ Pipe Lined  
Invert Depth: **8.21** (ft.) Flow Characteristics: **Fast**  
Deposits: ☒ None ☐ Mud ☐ Sludge ☐ Debris ☐ Grease  
Silt Depth: **0** (in.) Deposits Extent:  
Infiltration: **None** Pipe Seal Cond: **Sound**

Drop: **Outside** Rod and Bar  
Angled: **Yes** Reading: **16.55** (ft.)  
Inv Depth: **17.55** (ft.)

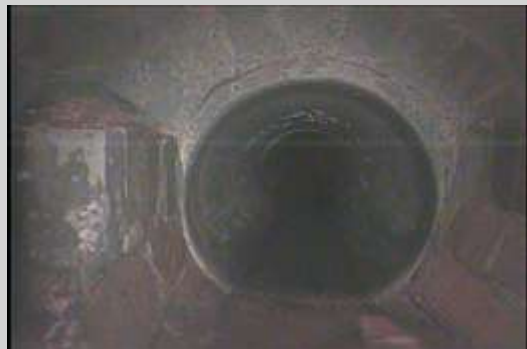
6 O'Clock Inflow

12 in. Circular Gravity Sewer  
Pipe In @ 6 O'Clock

Infiltration: **None** Pipe Seal Cond: **Sound**
